Manhole Inspection Summary

Manhole # S47CC_052MH

Insp Date: **2/4/08 1:03 PM**

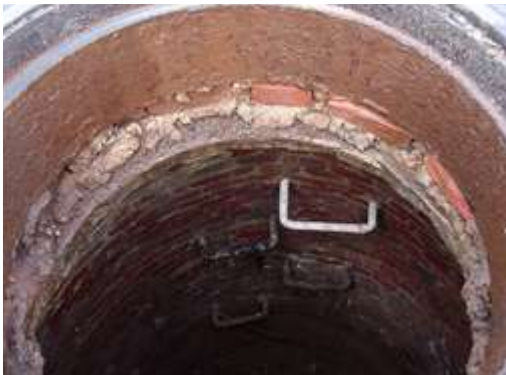
Defect 1

☒ **Leaks**

Infiltration: ☐ None ☐ Joint ☐ Cracks ☐ Mortar ☐ Roots ☒ **Wall**

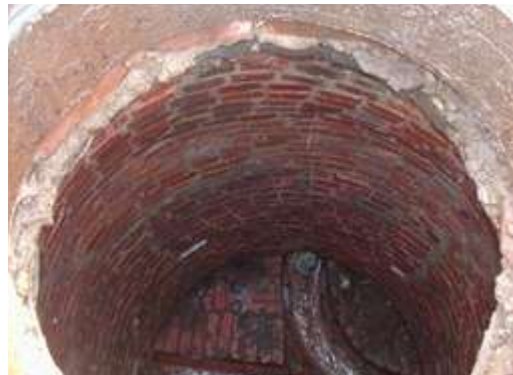
Defect 2

Count: **4** Missing: **0** ☒ **Corroded**

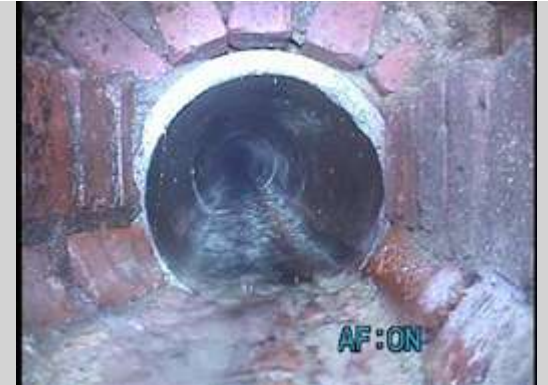
12 O'Clock Outflow

10 in. Circular Gravity Sewer
Pipe Out @ 12 O'Clock

Pipe Height: **8.4** (in.) Rod and Bar (Angled)
Pipe Material: **Clay** ☐ Pipe Lined
Invert Depth: **8.95** (ft.) Flow Characteristics: **Fast**
Deposits: ☒ None ☐ Mud ☐ Sludge ☐ Debris ☐ Grease
Silt Depth: (in.) Deposits Extent:
Infiltration: **None** Pipe Seal Cond: **Sound**

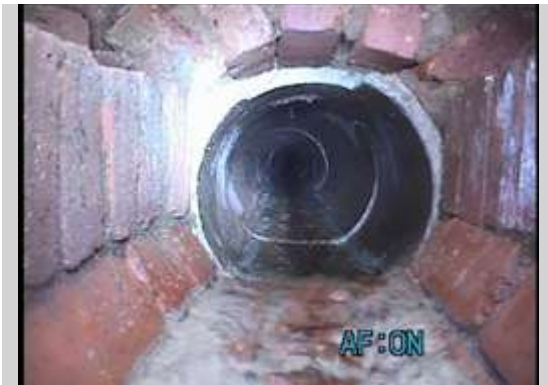
6 O'Clock Inflow

10 in. Circular Gravity Sewer
Pipe In @ 6 O'Clock

Pipe Height: **8.4** (in.) Rod and Bar (Angled)
Pipe Material: **Clay** ☐ Pipe Lined
Invert Depth: **8.90** (ft.) Flow Characteristics: **Fast**
Deposits: ☒ None ☐ Mud ☐ Sludge ☐ Debris ☐ Grease
Silt Depth: (in.) Deposits Extent:
Infiltration: **None** Pipe Seal Cond: **Sound**

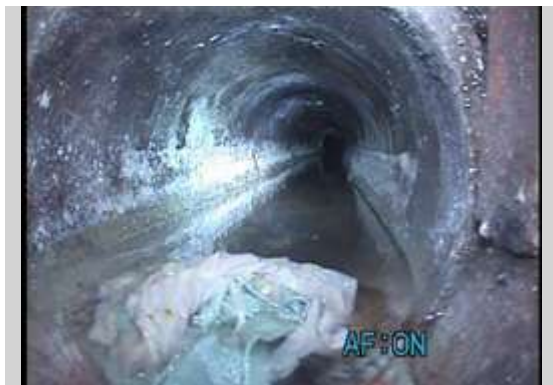
9 O'Clock Inflow

8 in. Circular Gravity Sewer

Pipe In @ 9 O'Clock

Infiltration: **None** Pipe Seal Cond: **Sound**
